Fire Investigation in an Industrial Grade Nitrocellulose Plant

Murthy TSN^{1*}, Baggi TR^{2,4}, Hiren NJ³ and Harika K⁴

ABSTRACT

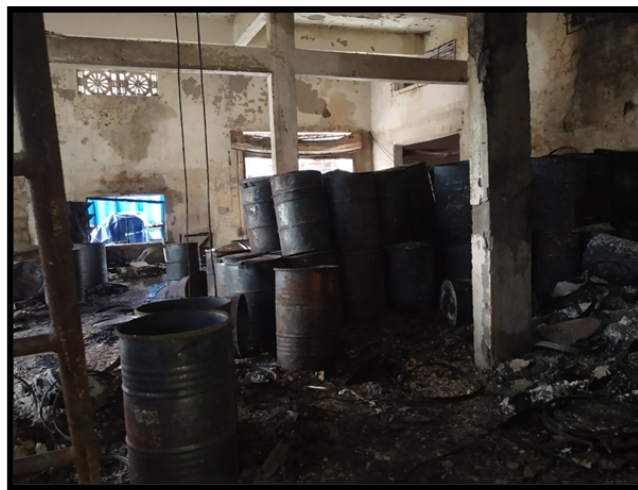
Figure 3. Different Sizes of the Drums.

In the raw material storage area, finished products (solvent nitrocellulose) in different sizes of drums were stored in

addition to raw material (wet nitrocellulose). All the material stored in the storage area was found to be partially burnt (Figure 3).

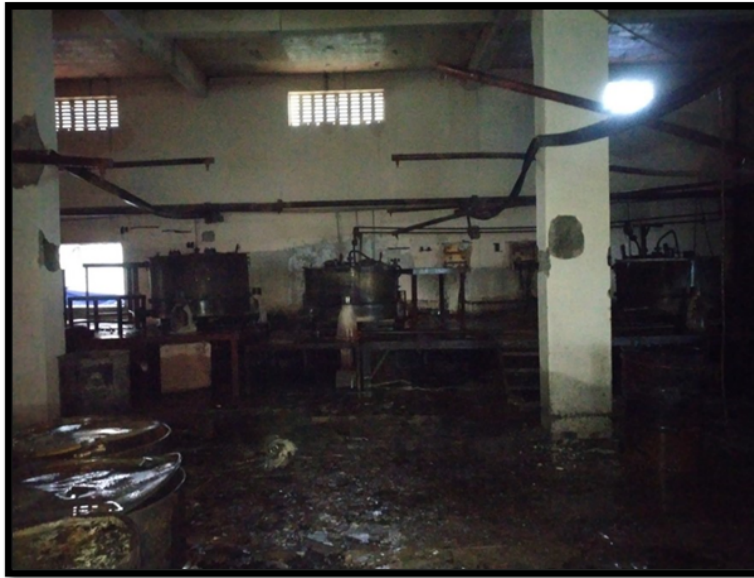
Figure 4. Centrifuges in the Manufacturing area.

The manufacturing area contained three centrifuges (Figure 4) on the southeastern side adjacent to the wall which were

superficially affected by fire. 200 drums kept in the manufacturing area were found to be partially burnt.

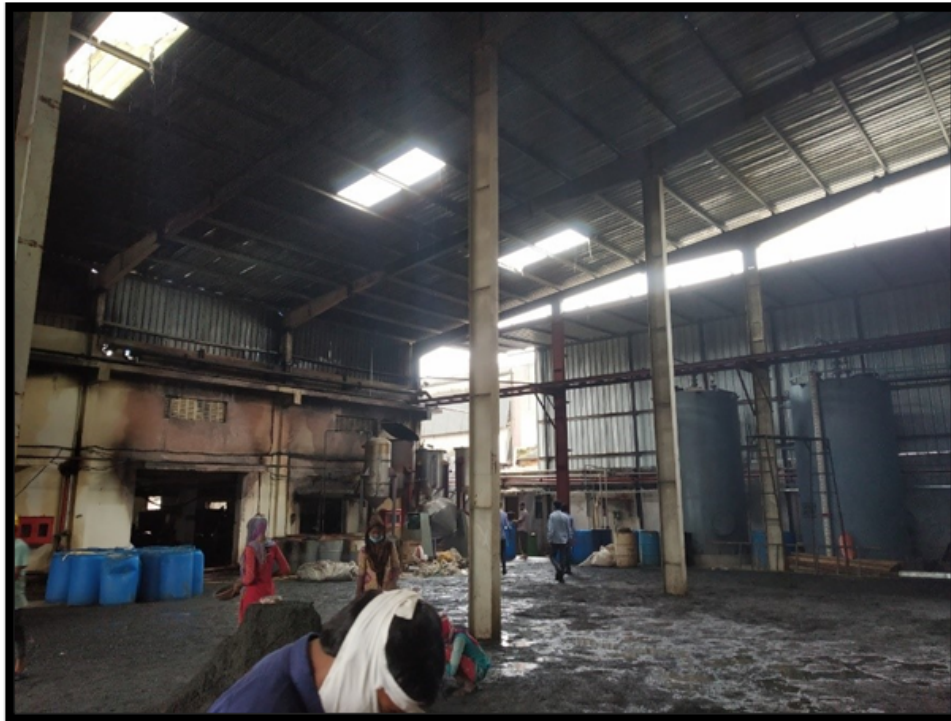
Figure 5. Finished products storage area.

The finished product storage area (Figure 5) (adjoining the manufacturing area) was found to be partially affected by

fire. The solvent tanks in the finished product storage area were found to be totally intact and were not affected by fire.

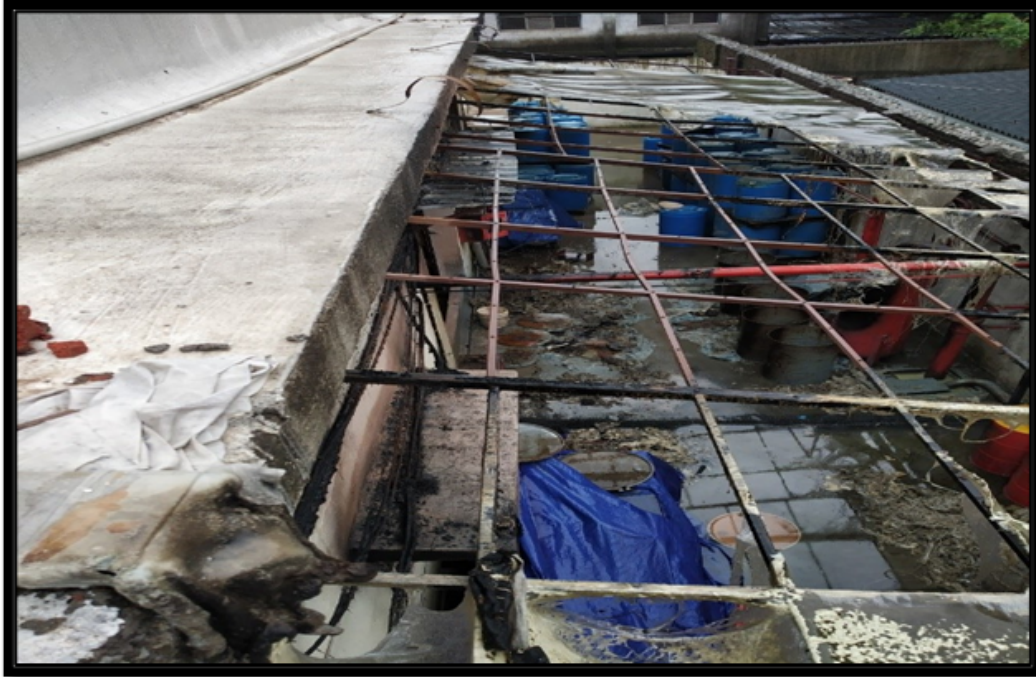
Figure 6. Working Shed.

The working shed located behind the building of the manufacturing and raw material storage area was found to be superficially affected by fire. Even though the roof was

burnt, the drums and panel boards located there were not affected by fire (Figure 6).

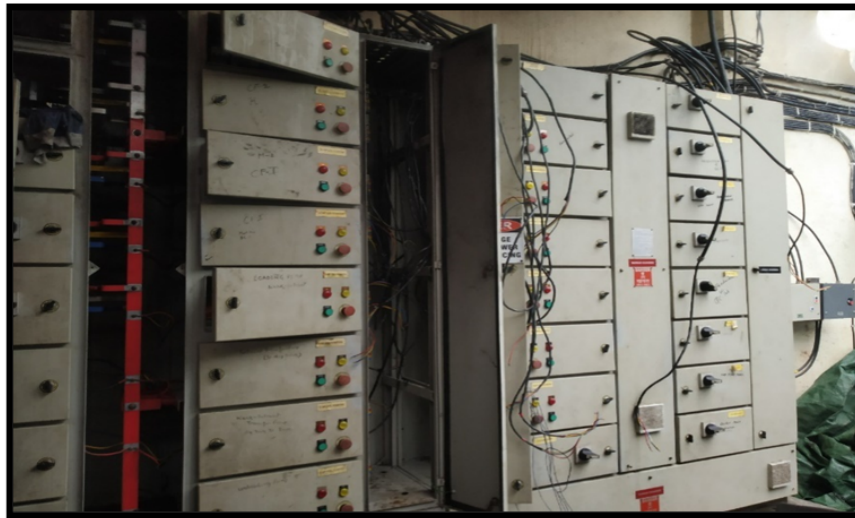
Figure 7. Electrical Panel Board.

The electrical panel located in the working shed was not affected by fire (Figure 7).

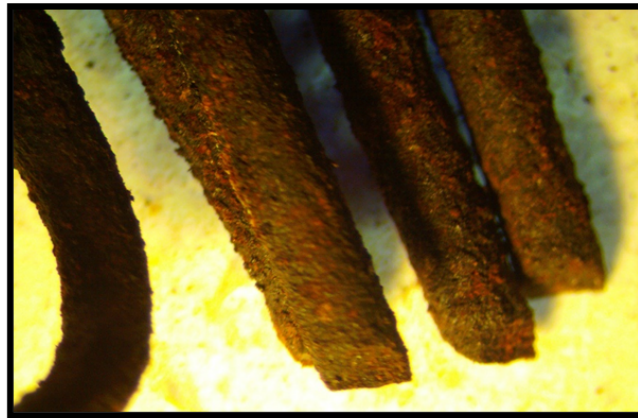
Figure 8. Stereomicroscopic Results.

The stereomicroscopic examination of the burnt wires did not show any symptoms of short circuit such as Beading (one of the images is shown in (Figure 8)).

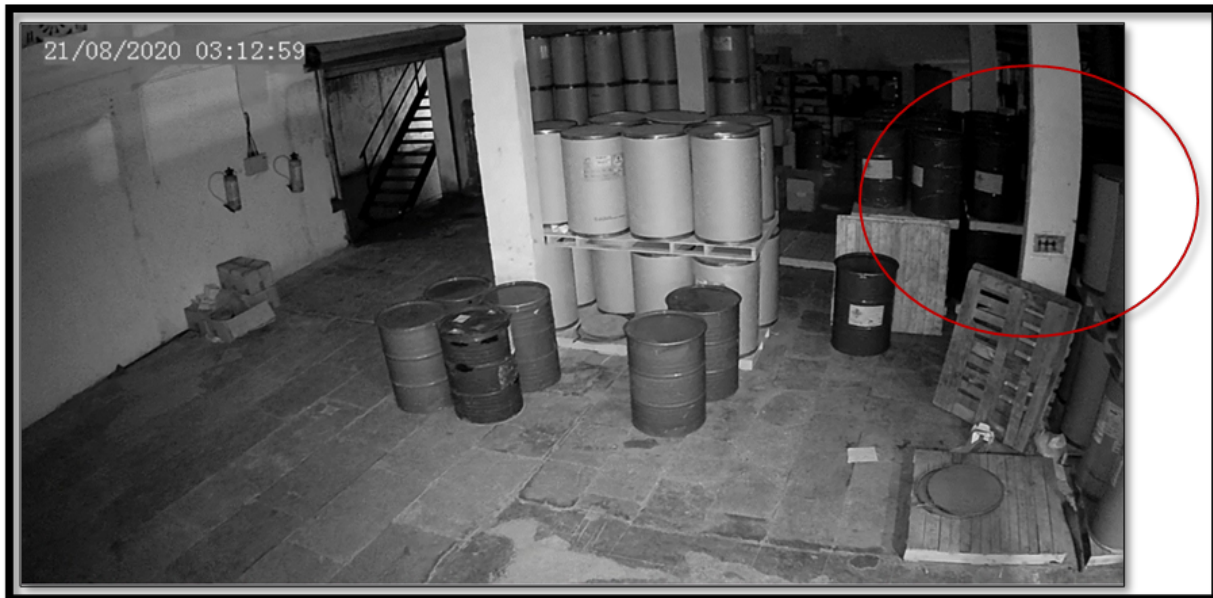
The CCTV footages of Cam 2 fixed above the door between passage in the office to the raw material storage area showed a flash of light at 03:13:01 in the manufacturing area. The snapshot before the flash Figure 9 and after the flash Figure 10 is shown below.

Figure 9. Before the blast flash (marked in red).

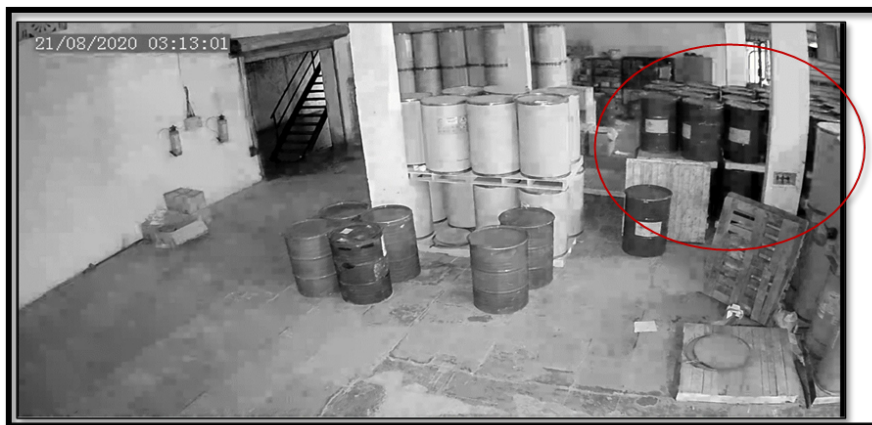
Figure 10. After the blast flash (marked in red).

The CCTV footages of Cam 6 located near the water tank in the compound wall besides the working area (and behind the raw material storage area) also showed a flash of light at 03:13:01. From the above, it is concluded that the fire originated at 03:13:01 with a burst of flame in the manufacturing area. This could happen only due to sudden ignition of solvents Isopropyl Alcohol, Butanol and nitrocellulose that were used in the manufacturing process. These substances even though flammable require external ignition to catch fire. At the time of fire incident, there was no manufacturing activity in the factory and no high-power drawing machinery/equipment was being used. The transformer and its circuitry were found to be in normal working order and no symptoms of short circuit were noticed in the electrical wires collected in and around the switch board of the manufacturing area such as beading and hence fire due to short circuit or any other electrical related causes was ruled out. As the plant was closed, fire caused due to friction due to some worker inadvertently dragging the drums on the concrete floor was also ruled out. As there was tight security, the workers/employees bringing cigarette/match boxes into the premises and consequent fire due to negligence was ruled out. The results of GC-MS analysis of the fire debris samples collected at four out of five locations in the plant showed the presence of hydrocarbons belonging to fire accelerants such as diesel/kerosene. As these hydrocarbons cannot be found in the combustion products of the solvents used for manufacturing purposes, their presence in the debris collected indicates an external ingress of diesel/kerosene. Further, the detection of hydrocarbons at four different locations inside the factory also indicates multiple origins of fire. However, these could not be captured in the CCTV footages as no camera was focused on these areas.
