Restoration of Fractured and Discolored Anterior Tooth: A Case Report

Anterior tooth fracture is a dental structural abnormality that can lead to genuine esthetic problems. The treatment of patient with fractured and discolored teeth is very challenging. A comprehensive clinical examination involving vitality test findings, dislocation of teeth, percussion analysis findings, and injuries of periodontal tissues, is crucial to determine the appropriate treatment plan. In this article, a 24-year-old female patient consults for restoring her fractured and discolored central incisor because of its unaesthetic appearance. The fracture line's position and the tooth necrosis excluded treatment modalities such as veneers in favor of full coverage. The incisor was restored with zirconium based crown.

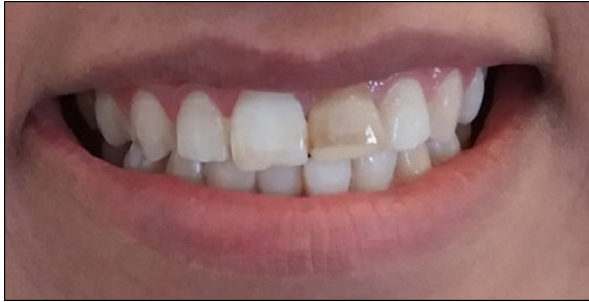
A 24-year-old female patient attended to the department of fixed prosthodontics for restoring her fractured central incisor because of its unaesthetic appearance (**Figure 1**). Thermal and electric pulp testing revealed that the tooth was necrotic.

Figure 1. The initial smile.

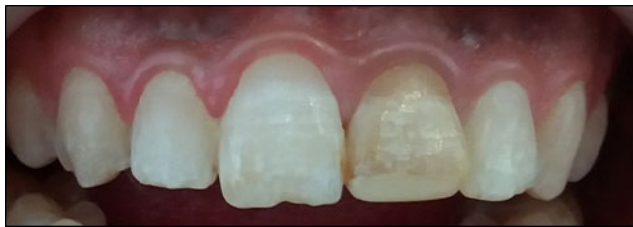
The patient's anamnesis revealed that the tooth had been fractured 2 years ago during an accident. Direct composite restorations had been placed one month after the trauma. The patient had no complaint, except for the unaesthetic appearance due to the dyschromia of the fractured incisor. A zirconia-based crown was indicated (**Figure 2**).

Figure 2. Discoloration of the central incisor.

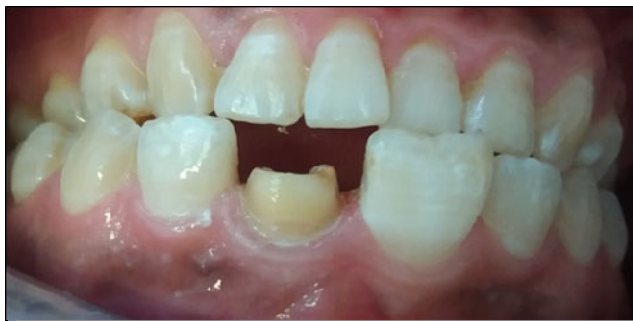
Before tooth preparation, root canal treatment was done. The defective composite was removed and the tooth was prepared (**Figure 3**).

Figure 3. Tooth preparation.

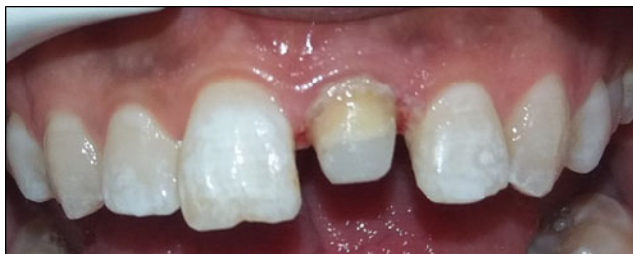
Thereafter, a glass fiber post was placed. The esthetic core was built up with composite resin and bonded with self-adhesive bonding resin (**Figure 4**).

Figure 4. Fiber post-reconstruction.

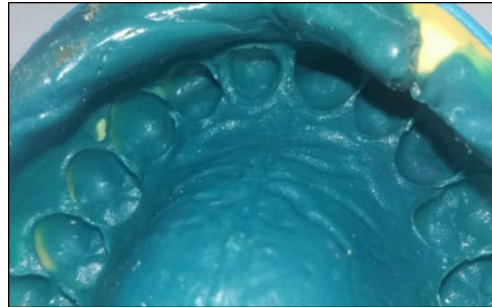
After master impression (**Figures 5 & 6**), working cast was performed, and scanned. A zirconia-based crown was milled by CAD/CAM.

Figure 5. Master impression.

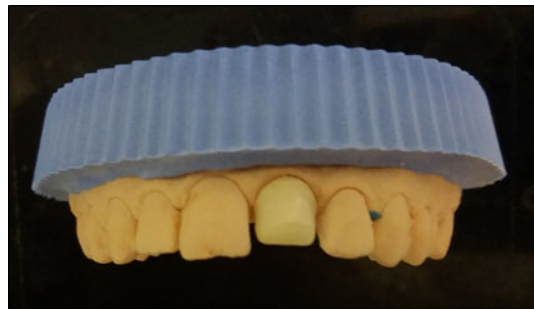
Figure 6. CAD/CAM zirconia coping.

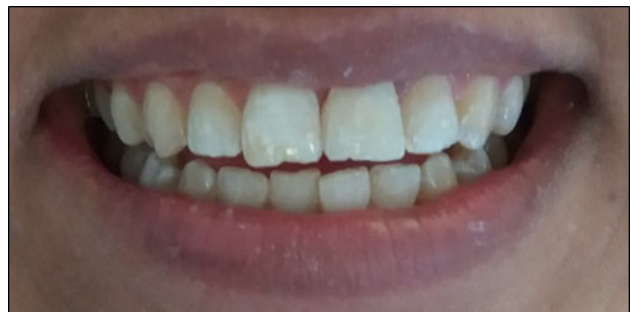
Then, the crown was checked intraorally and the entire cementation procedure was performed. A three-month follow-up asserted complete patient satisfaction with regard to her smile (**Figure 7**).

Figure 7. Esthetic outcome.
